ErSed Reference: 19007-ERM-R-24-210707

SSD 7348 - Oakdale West Industrial Estate (OWE)

Environmental Representative: Monthly Report (ERM-R #24)

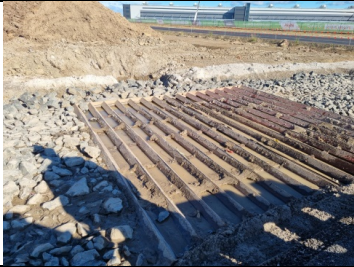
18/06/21

The new control in this location was discussed.

The rock under the cattle grid need to be refreshed occasionally to allow the water to free drain away to a sump and the swale to the basin.

It was confirmed that this will be monitored and cleared as required. It was recommended that this is done prior to days where larger numbers of movements are expected so that function can be maximised for these days.

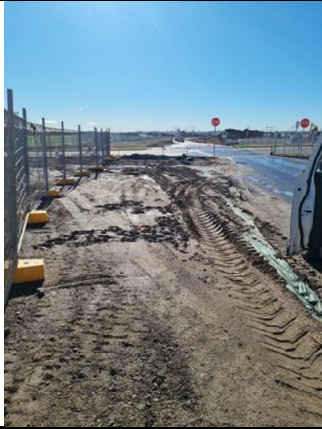
18/06/21

A corner area has had the sediment fence removed for access.

The corner is being used for a pull off area and mud is being tracked to the CAR.

This area should be closed to access and sediment fence reinstated.

Loose material should be removed from the road side to prevent it being washed onto the road by the sweeper.
