ErSed Reference: 19007-ERMR-29-211207

SSD 7348 - Oakdale West Industrial Estate (OWE)

Environmental Representative: Monthly Report (ERMR #29)

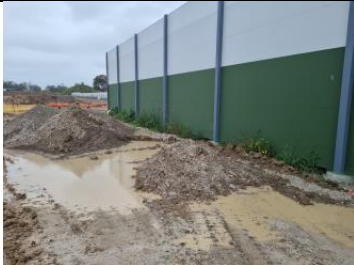
11/11/21 – LOT3A
Water is pooling against the noise wall.

It was confirmed that water should not be allowed to pass out under the wall as this may drain offsite and bypass the outer estate basin.

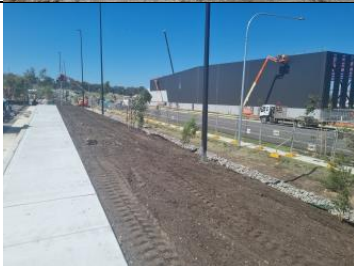
18/11/21 – LOT2B
Landscape works are progressing at the western batter.

Sediment control has been removed to allow the works so stabilisation/finalisation of the works will need to be completed as a priority.

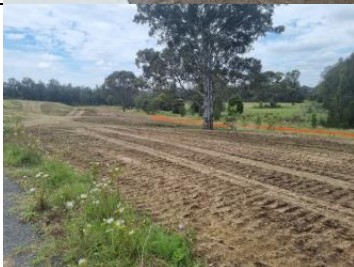
24/11/21 – INFRASTRUCTURE
It was discussed that grass establishment over this area has not been as successful as expected.

This area should be monitored and extra treatment undertaken if required.

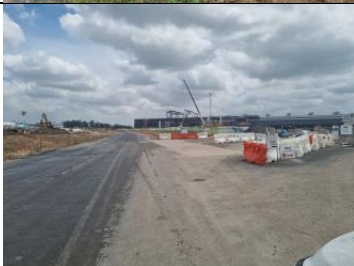
24/11/21 – CAR AND ROADS
The entrance / exit from Lot 1A is clean and stable
