ErSed Reference: 19007-ERMR-32-220703

SSD 7348 - Oakdale West Industrial Estate (OWE)

Environmental Representative: Monthly Report (ERMR #32)

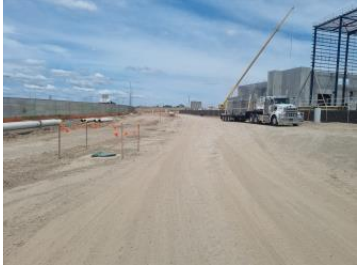
<p>3/11/21</p> <p>It was discussed that dust is being raised by trucks being moved through this area. Wind seems to be deflected by the Low Bay building and directed to the east.</p> <p>Dust control through this area will need to be an ongoing management concern.</p> <p>12/12/21</p> <p>Note: no issues have been raised in this area through ongoing monitoring in accordance with the AQMP.</p>

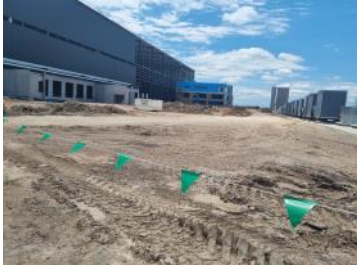
<p>28 JAN 2022</p> <p>Ongoing dust control was discussed. It was indicated that there has been little dust issues at the site because of the recent wet conditions.</p> <p>It was noted that there have been no actions or alerts requiring attention from either the PM10 monitoring stations or the deposition monitoring stations. All monitoring has been within the parameters set within the AQMP.</p>
<p>No Photo</p>	<p>Significant rainfall has been received over the site during the months of January (120mm & 14 rain days) and February (203mm & 17 rain days).</p> <p>As such dust has not been of concern during this wet period.</p>

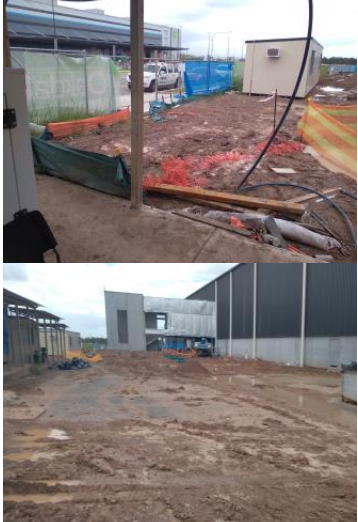
<p>20 JAN Lot 1BC</p> <p>The sediment fence at the entrance area is partially collapsed.</p> <p>Inspect sediment fences generally and reinstate where required.</p> <p>A large catchment in-front of the site offices seems to drain towards the site entrance area.</p> <p>Re shape and grade area as required to direct surface water towards the new pits and sediment control.</p> <p>See item closed below - 04 MARCH 22</p>

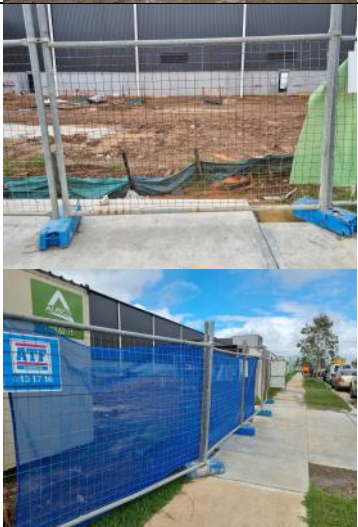
<p>04 MARCH 22 –</p> <p>Item raised 20 JAN 22 closed: See photos and comments below.</p> <p>Sediment fence has been repaired. There is no evidence of water washing from the site entrance through to the footpath.</p>

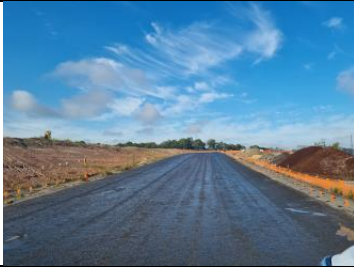
17 FEB 22 –

The CAR surface has been washed and swept.

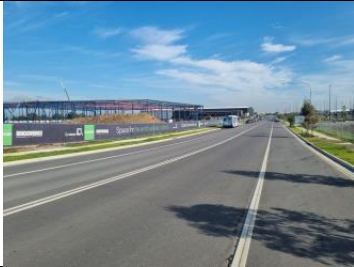
17 FEB 22

ROAD 3 - The road surface has been swept.

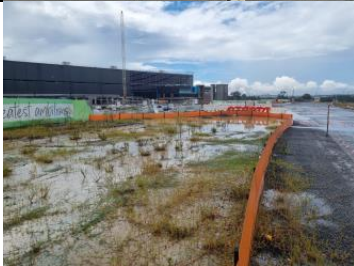
22 FEB 22 – Lot 1BC/Lot 1A External

During heavy rainfall, surface water has passed over to the verge to the CAR and flows to the entrance to Lot 1A.

The CAR is graded to the east. The verge to the west is either flat or grades to the west.

A low berm of spoil is created along the toe of the sediment fence. This acts to detain water within the verge.

The sediment fence is also acting to detain water from passing out to through to the CAR to the east.
