ErSed Reference: 19007-ERMR-34-220507

SSD 7348 - Oakdale West Industrial Estate (OWE)

Environmental Representative: Monthly Report (ERMR #34)

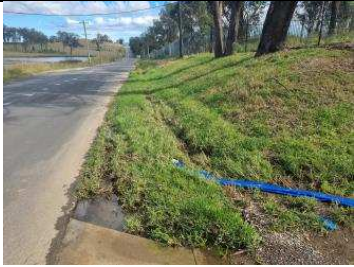
21 April 22 – Bakers Lane

The site was inspected following concerns raised by the Department of Planning.

Concerns raised by DPIE were discussed. The contractor indicated that they will;

- Slash the swale drain adjacent to Bakers Lane to increase its capacity.
- Move the lay flat hoses to the upper side of the batter to Bakers Lane so that water can be more readily taken down to culvert in front of the school which is where the water passes to the head of the creek to the west.
- Ensure that dewatering activities are monitored
